Monitoring Data Record

Project Title: R-2248BB – Charlotte Outer Loop COE Action ID: 200131321  
 Stream Name: UT Thomas Pond (Site 9) DWQ Number: 011231  
 City, County and other Location Information: Mecklenburg County, Charlotte Outer Loop, NC 27 Exit (Mount Holly Road)  
 Date Construction Completed: April 2005 Monitoring Year: ( 2 ) of 5  
 Ecoregion: \_\_\_\_\_ 8 digit HUC unit 03050101  
 USGS Quad Name and Coordinates: \_\_\_\_\_

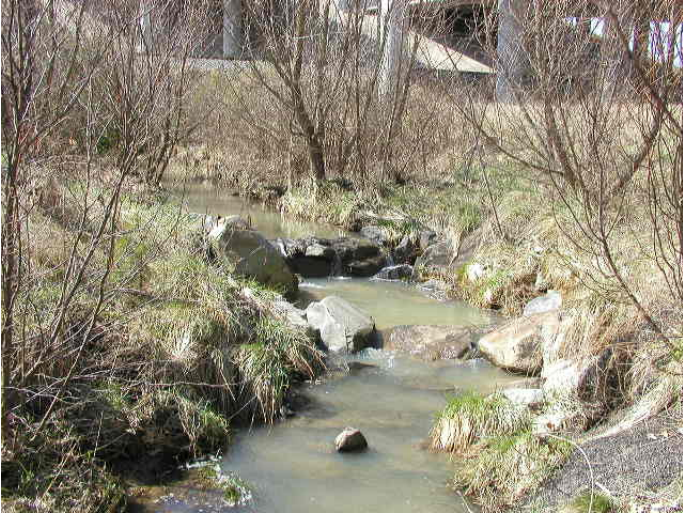
UT Thomas Pond stream relocation is experiencing some instability for the Year 2 Winter evaluation. The crossvane at Sta. 217+80 -L- Photo Point #1 (Upstream) which had water piping under the crossvane last monitoring evaluation is functioning properly and water is flowing over structure. A slight headcut has formed at Sta 219+00 -L- which is downstream of Photo Point #3. Another slight headcut has started to form at Sta. 1+00 Loop E, which is located between Photo Point #4 and #5. There were no grade control structures installed within the sections of stream where these headcuts have formed. These minor headcuts are not affecting the overall stability of the stream. There is evidence that a bankfull event has occurred since the last monitoring evaluation. NCDOT will continue to monitor this stream relocation for channel stability and to see if any remedial action is warranted.

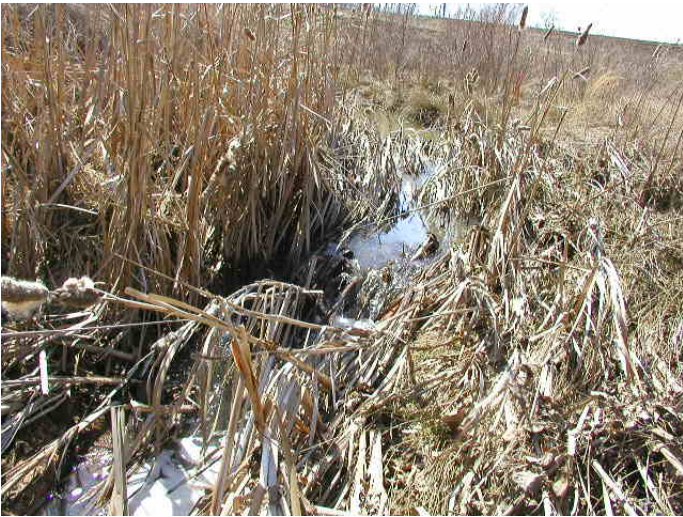
| Head cut or<br>down cut<br>present? | Headcut has<br>formed | Headcut has<br>formed | | | |

Photo of headcut noted @ Sta. 219+00 –L  
Year 2 Winter – March 2009

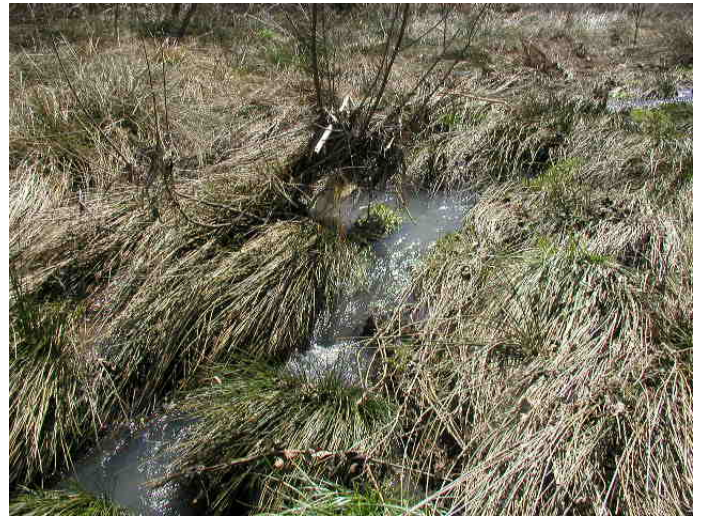
Photo of minor headcut noted @ Sta. 1+00 Loop E
